# 压气机轴向扩压器叶片断裂分析

**摘要:** 为了确定航空发动机压气机轴向扩压器叶片断裂故障的断裂性质和产生原因, 通过外观检查、断口分析、组织检查、硬度测试等手段进行初步检验, 并从材料、设计、加工以及环境方面进行详细的故障分析。结果表明: 轴向扩压器叶片断裂故障为高周疲劳断裂。在航空发动机工作状态下轴向扩压器发生共振, 且在工作温度下轴向扩压器叶尖与后盖为过盈配合, 此时叶尖与后盖发生刮摩, 叶尖出现毛刺及划痕, 在轴向扩压器叶片从靠近叶尖的共振节线处共振应力最大点的叶盆侧开始产生裂纹, 最终发生高周疲劳断裂。建议增大轴向扩压器叶片厚度与前、后缘圆角和轴向扩压器叶片与后盖之间的配合间隙, 以避免类似故障发生。

## Fracture Analysis of Compressor Axial Diffuser Blade

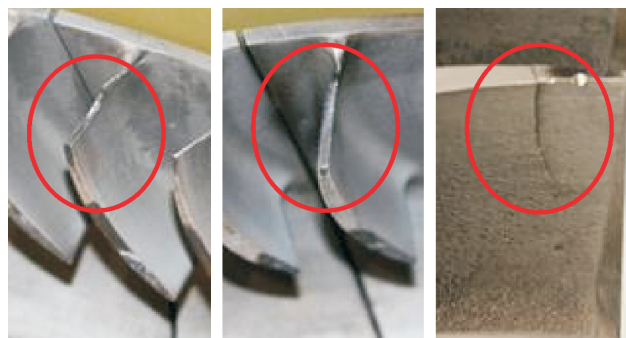
图1 轴向扩压器掉块、裂纹宏观形貌

轴向扩压器2片叶片掉块、1片叶片有裂纹的宏观形貌如图1所示。从图中可见,轴向扩压器2片掉块叶片均为靠近切缝处叶片,裂纹叶片为靠近另一端切缝的第4片叶片。

切取轴向扩压器掉块部位,经体视显微镜观察,2处叶片掉块位置、形貌均相似,均呈L形,由叶尖沿径向扩展一段距离后转向轴向扩展,尺寸约为10 mm×5 mm。径向断口较平坦,表面呈黑色,轴向断口较粗糙,有灰

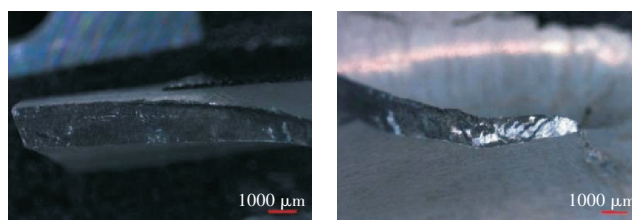
图2 掉块叶片径向和轴向断口宏观形貌

色金属光泽,局部可见纤维状断裂特征,掉块叶片径向和轴向断口宏观形貌如图2所示。观察轴向扩压器与后盖相配处的端面痕迹,出现掉块的叶片端面靠近进气边位置均存在较严重的磨损痕迹,如图3所示。

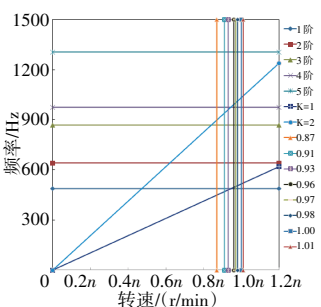
图 6 叶片共振坎贝尔图

从图中可见,轴向扩压器在各常用工作转速和离心压气机转子高周疲劳试验转速下可能由不同的激振源引起不同阶次的共振,需结合各阶模态的振型和振动应力进行共振分析。在前 5 阶模态中,与轴向扩压器裂纹、掉块模式较相似的振型为第 4 阶,该阶振型及振动应力分布如图 7 所示。

从表中可见,轴向扩压器在 2 倍激振源频率( $K=2$ )时,频率裕度较小,可能在 0.97 $n$ 、0.98 $n$ 、 $n$  和 1.01 $n$  常用工作转速下以及 0.87 $n$ 、0.91 $n$ 、0.93 $n$  和 0.96 $n$  高周疲劳试验转速下引起第 4 阶共振,导致叶片出现裂纹、掉块,故该底事件无法排除。

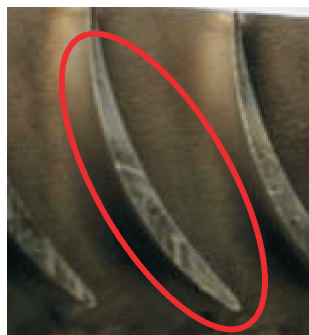
图9 轴向扩压器压痕

从航空发动机零件外观检查的结果可见,轴向扩压器叶尖与后盖配合面均可观察到明显因过盈产

生的压痕,轴向扩压器压痕和后盖压痕分别如图9、10所示。

作状态下产生过盈,在轴向扩压器叶片与后盖过盈状态下若轴向扩压器发生共振,很可能产生叶片叶尖与后盖外径的刮摩,导致轴向扩压器叶片叶尖产生毛刺,可能促使裂纹的萌生,故该底事件无法排除。

建议优化轴向扩压器叶型,增大叶片厚度及前、后缘圆角。除此之外,增大轴向扩压器叶片与后盖的配合间隙,以减少航空发动机在工作状态下轴向扩压器叶片与后盖产生过盈的可能性,避免类似故障再次发生。
